Matrox Imaging helps keep trains on the right track

By Kelly Davis, Matrox Imaging

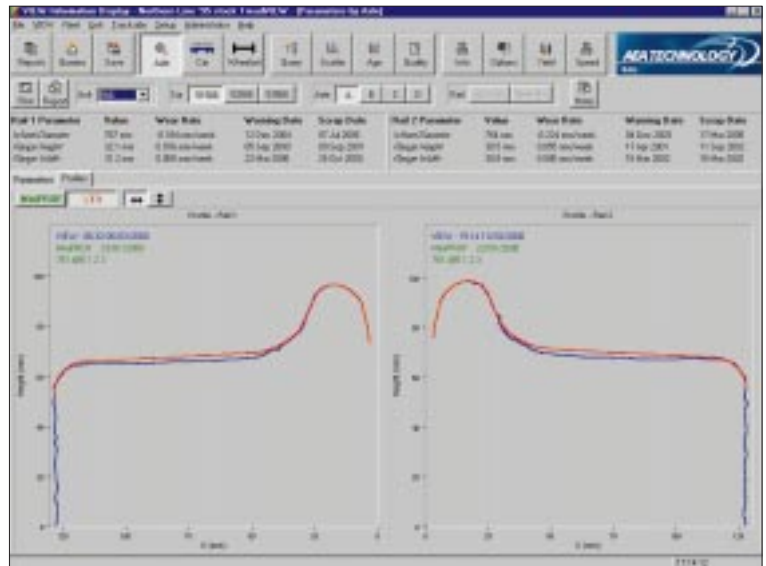
In comparative tests with the highly accurate hand-held ‘Miniprof’ gauge used in manual wheel checks, Treadview is proving accurate to within 0.5mm on a moving vehicle – this is sufficient for providing regular measurements in a cost-effective manner. Pocock illustrates this by observing that it took a two-man team about three man-months to carry out a complete Miniprof assessment of one of the fleets on the London underground system, while the same job took

a mere seven days – without human intervention – once a TreadVIEW system had been installed. The rolling programme that Treadview makes possible enables the information that is gathered to be averaged and this reduces the already small possibility of error by a third.
